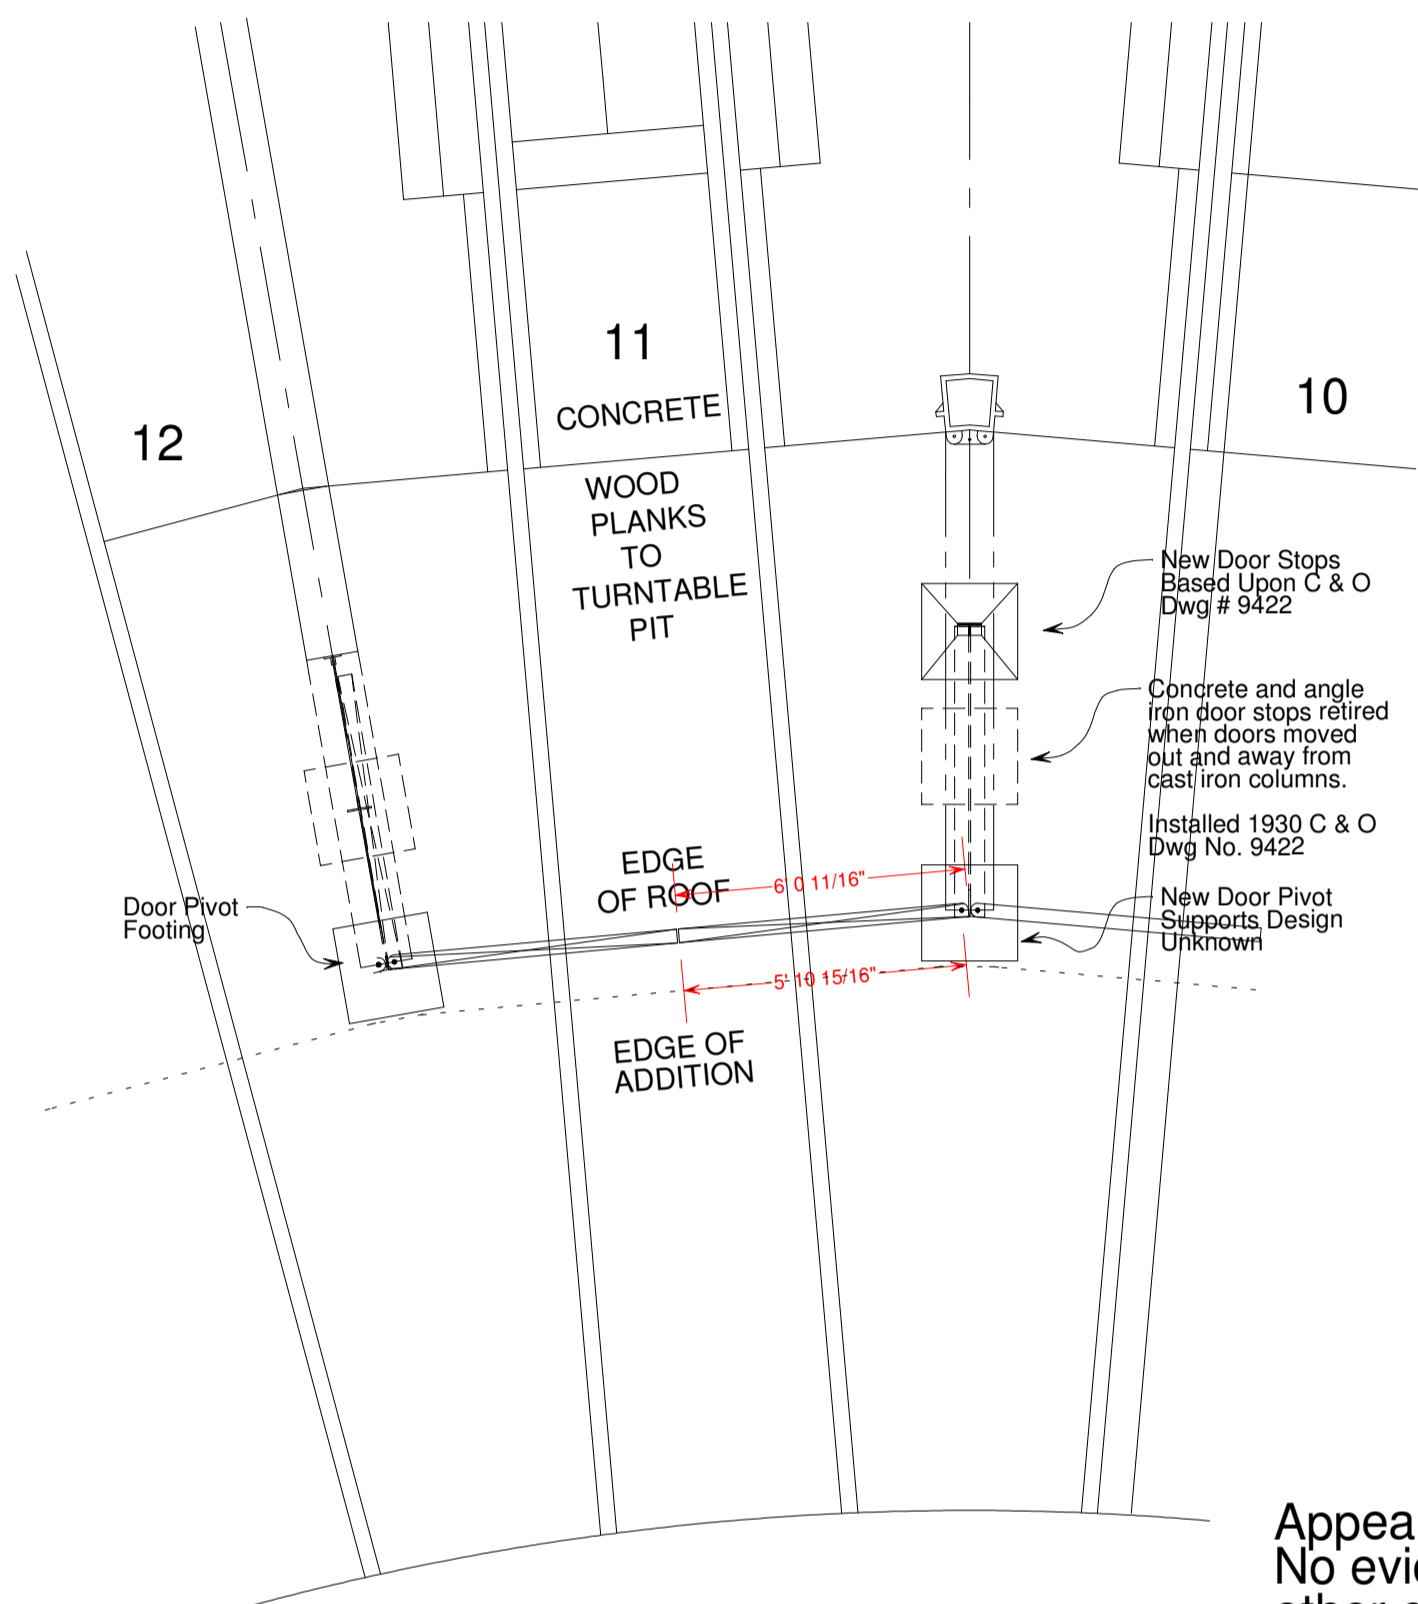
Appearance based upon photographs
No evidence of appearance of the other end before 1942 has been seen by the author. Appearance of opposite end of roundhouse was probably similar from mid to late 1930's to 1942-43 when the overhead doors were added to stalls 14 thru 17.

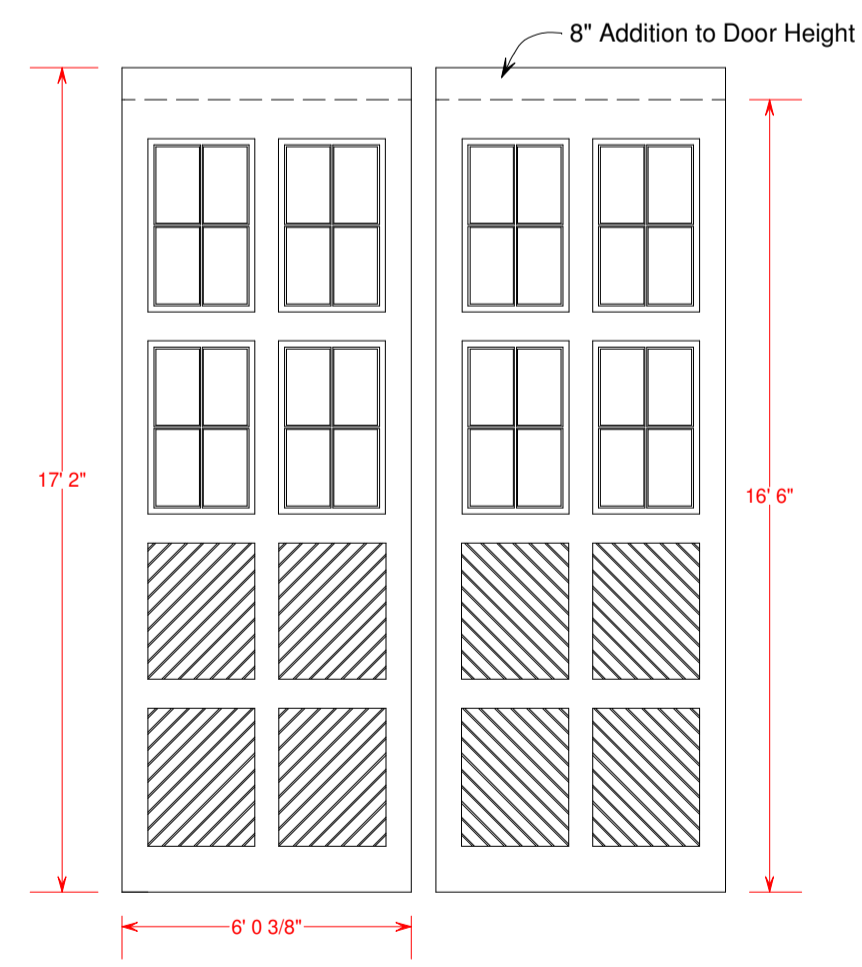
Appearance of doors based upon C & O Dwg No. 9422 (1930) and photographs.
Each door reduced in width by 5" - 2.5" on each side. For Stalls 1 thru 11

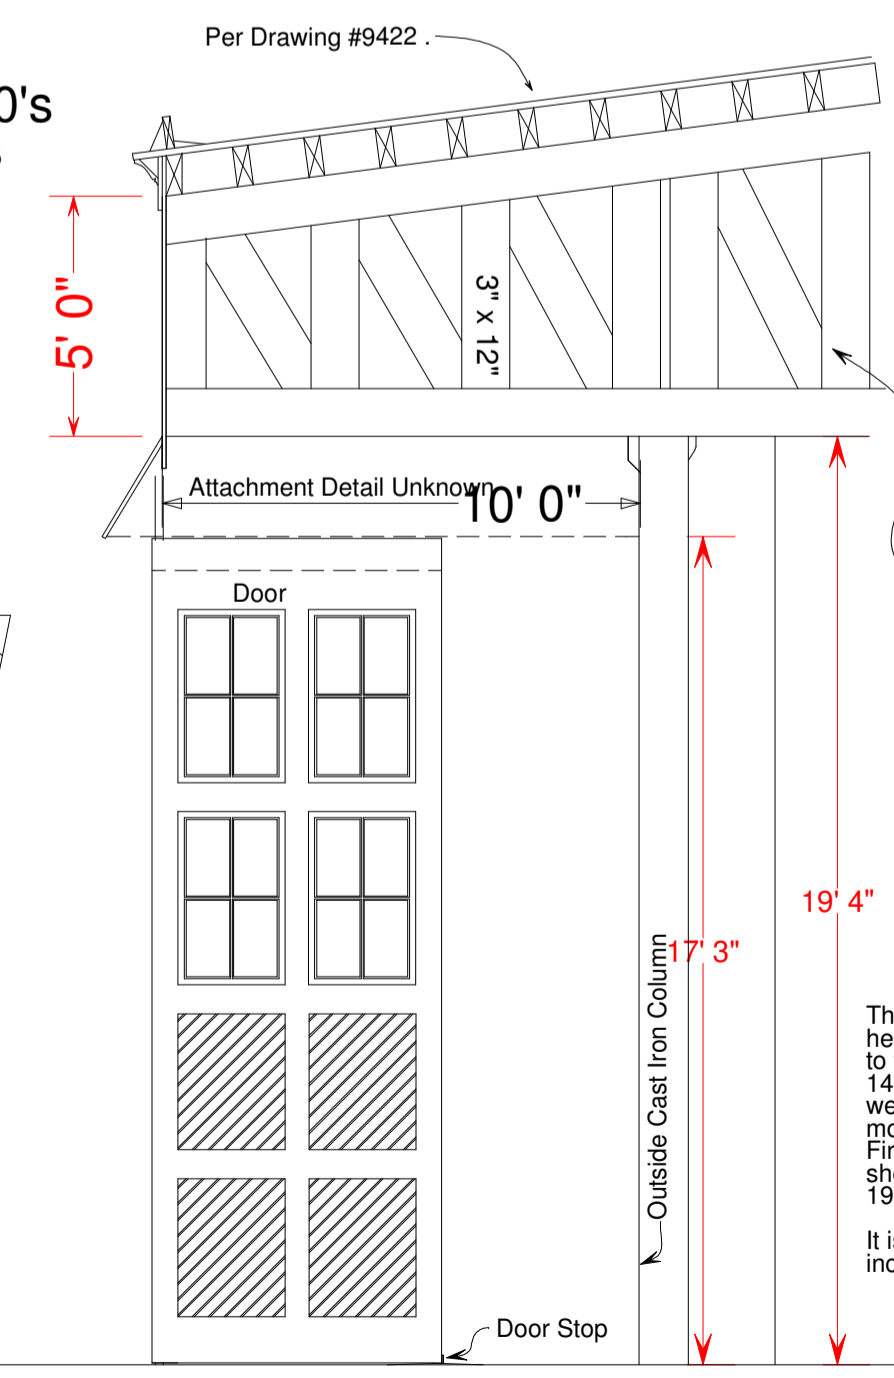
Drawings and Photographs indicate that 4' 0" for the front of the open web truss is correct.

This type truss used above (at minimum) stalls 1 thru 4. I have not reconciled the one foot difference in the two trusses.

Door Per C & O Dwg. No. 14549-A This may be correct for stalls 12 and 13, and 14 thru 17 before the overhead doors were installed.

The Doors on Stalls 5 thru 13 were increased in height in 1941 from 16' 6" to 17' 2" and 8" added to the height of the existing doors (C & O Dwg. No. 14549-A). That drawing also indicates that the doors were still mounted on the cast iron posts and not moved out as shown here and on the drawing of the Firewall of 1945. It would appear therefor that the shed structure was added at some point between 1941 and 1945.

It is not known if the doors on stalls 1 thru 4 were increased in height at an earlier or later time.
