TRUSS DRAWN AS ILLUSTRATED ON 1930 EXTENSION TO ROUNDHOUSE VERTICAL HEIGHT OF TRUSS TAKEN FROM FIREWALL PLAN OF 1946. ELEVATION SHOWS GENERAL APPEARANCE ABOVE STALLS 14-17 BASED UPON C & O DRAWINGS AND A PHOTOGRAPH TAKEN DURING REBUILDING OF THE ROUNDHOUSE ROOF BETWEEN 1910 AND 1916.

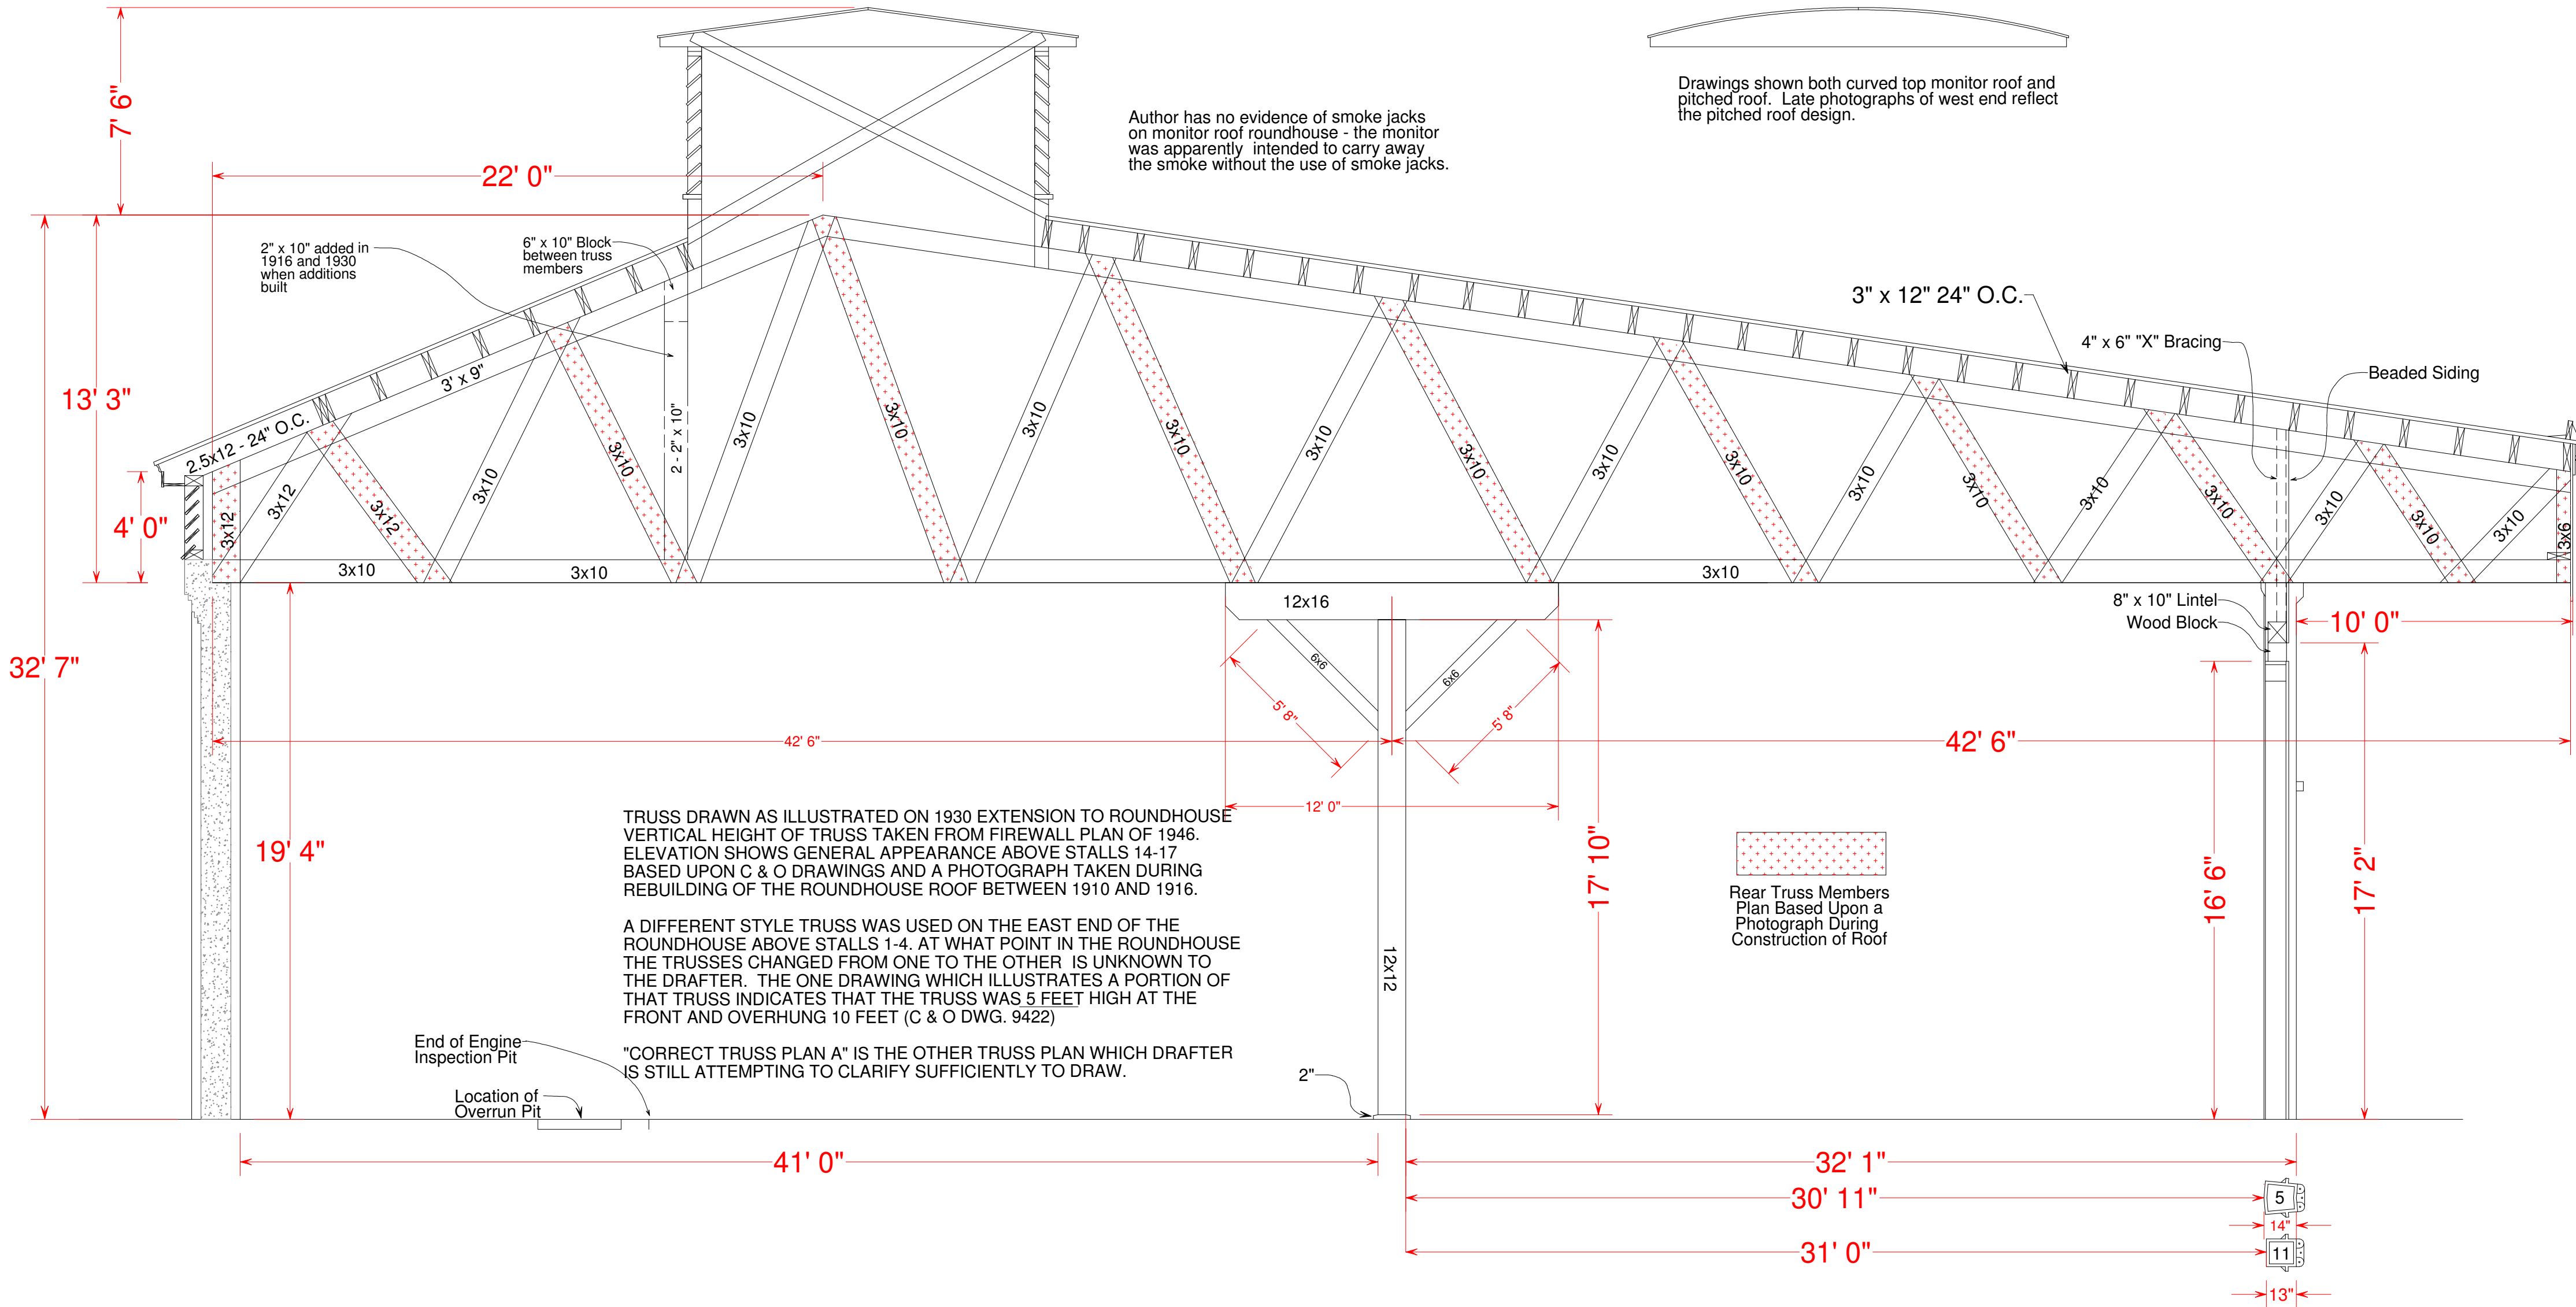
Drawings shown both curved top monitor roof and pitched roof. Late photographs of west end reflect the pitched roof design.

Author has no evidence of smoke jacks on monitor roof roundhouse - the monitor was apparently intended to carry away the smoke without the use of smoke jacks.

A DIFFERENT STYLE TRUSS WAS USED ON THE EAST END OF THE ROUNDHOUSE ABOVE STALLS 1-4. AT WHAT POINT IN THE ROUNDHOUSE THE TRUSSES CHANGED FROM ONE TO THE OTHER IS UNKNOWN TO THE DRAFTER. THE ONE DRAWING WHICH ILLUSTRATES A PORTION OF THAT TRUSS INDICATES THAT THE TRUSS WAS 5 FEET HIGH AT THE FRONT AND OVERHUNG 10 FEET (C & O DWG. 9422)

"CORRECT TRUSS PLAN A" IS THE OTHER TRUSS PLAN WHICH DRAFTER IS STILL ATTEMPTING TO CLARIFY SUFFICIENTLY TO DRAW.
